## **Auckland Council**

## Best Practice Guidelines for Universal Access During Change and Construction

Iteration: July 2023

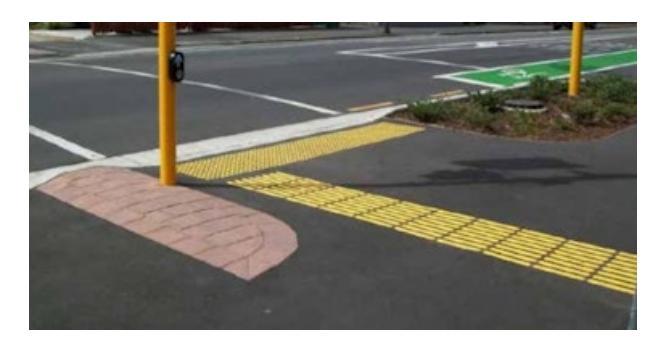
Directional and warning TGSI at pedestrian crossing

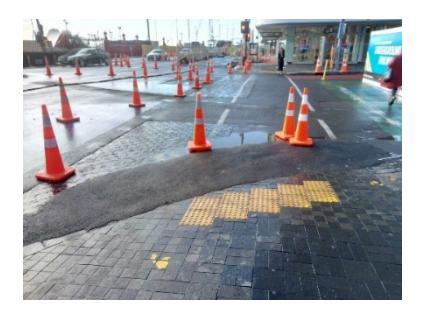
Photo 1: Cones on accessible crossing point

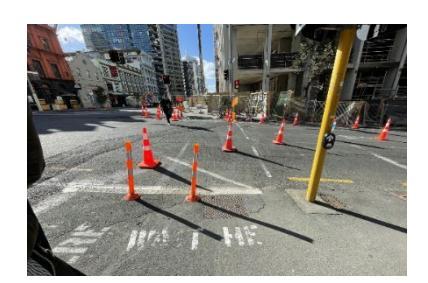
Photo 2: Hit sticks and cones at crossing point cause an obstruction and make people unsure if they can cross the road there

14.	Avoid the use of hit sticks or cones at pedestrian crossings as they need to be free of any obstructions to users. They can also cause confusion as it could appear that pedestrians are not permitted to cross at that point.	BP

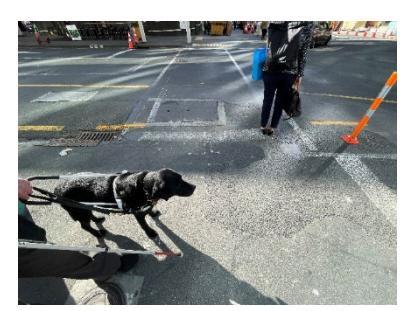
Photo 4: No temporary TGSIs at intersection

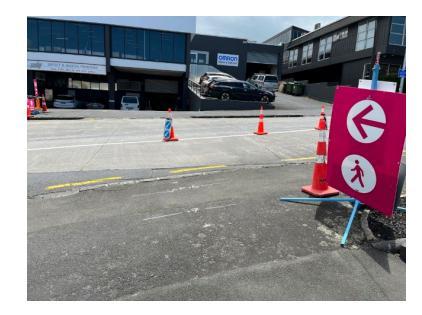
Photo 5: Signs do not line up on each side of the road at crossing point and no kerb ramp installed

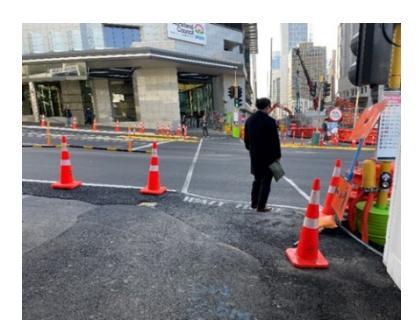
Photo 3: Cones around drum mounted signal pole make the push button unreachable for many people

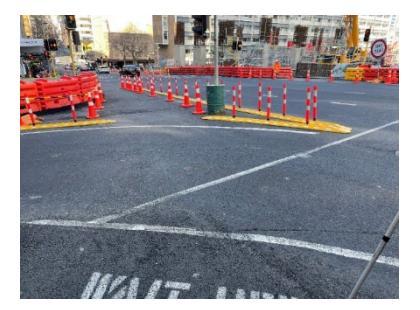
Photo 6: Crossing point has a wide sweeping radius, with no clearly marked direction of travel, making it confusing for people who are Blind or sight impaired

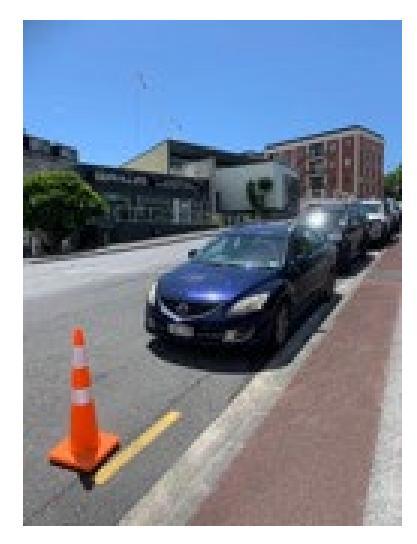
Photo 7: Parked cars blocking view for both pedestrians and drivers at temporary crossing point

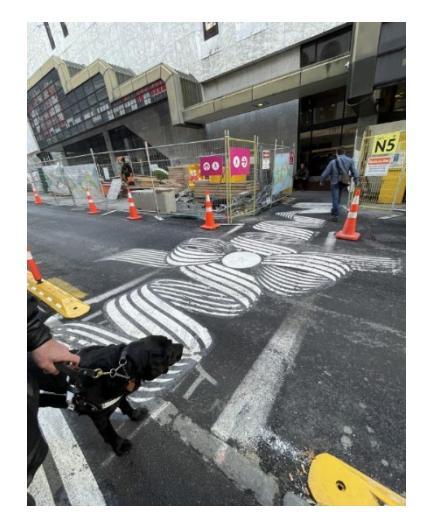
Photo 8: Mural on crossing point could cause confusion for people who are sight impaired or neurodiverse

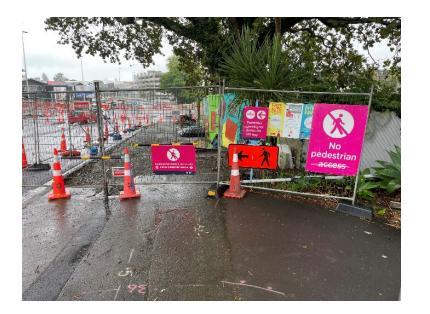
Photo 9: Multiple signs providing a variety of information creates visual clutter and make it hard to determine what is important

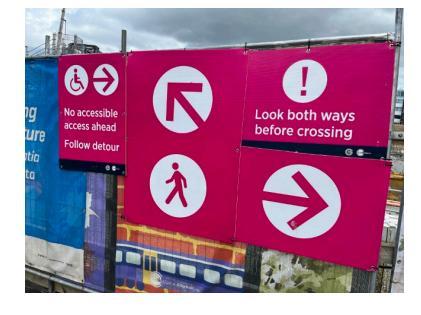
Photo 10: Incorrect signage positioning. Sign with ISA and right pointing arrow needs to be on the right side. Street names on signs would assist navigation

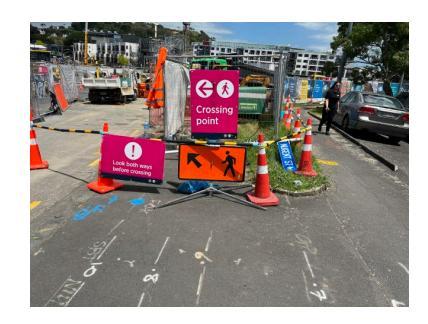
Photo 11: Directional signage arrows pointing in different directions

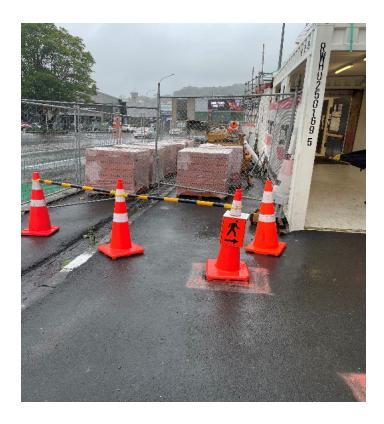
Photo 12: Directional sign fixed to a cone. Do not expect to see signs on cones and there is no colour contrast

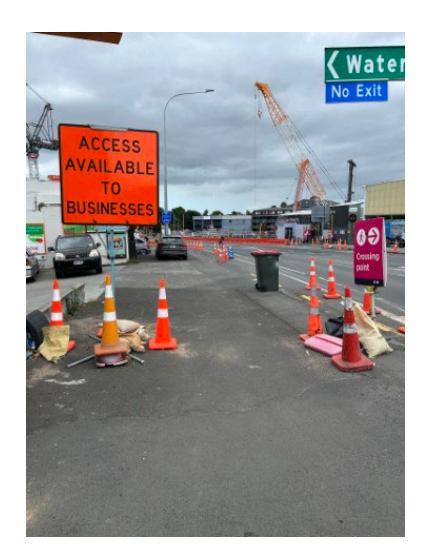
Photo 13: Signage on both sides of footpath narrowing the clear width

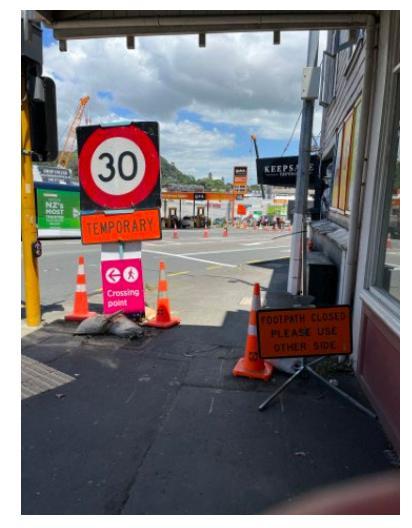
Photo 14: Signage on both sides of footpath narrowing the clear width and blocking the building line often used by Blind and sight impaired people

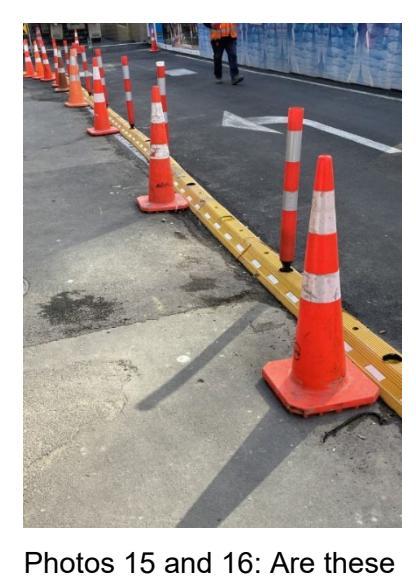
cones required? They narrow the clear path width and block the guideline provided by the raised yellow temporary kerbing that a Blind or sight impaired person may use. The raised

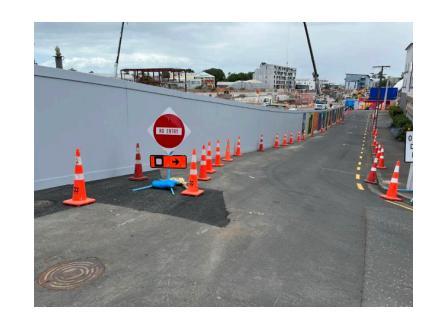
Photo 17: Cones on footpath on right of photo, narrow the clear footpath width

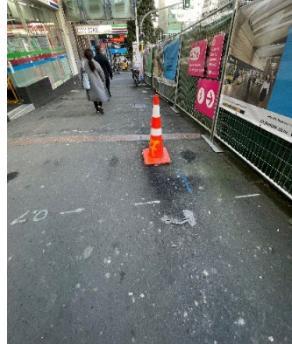
Photo 18: Redundant cone left on footpath

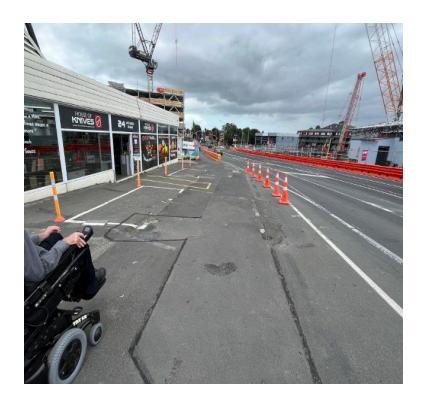
Photo 19: No defined footpath to differentiate footpath from retail parking and road

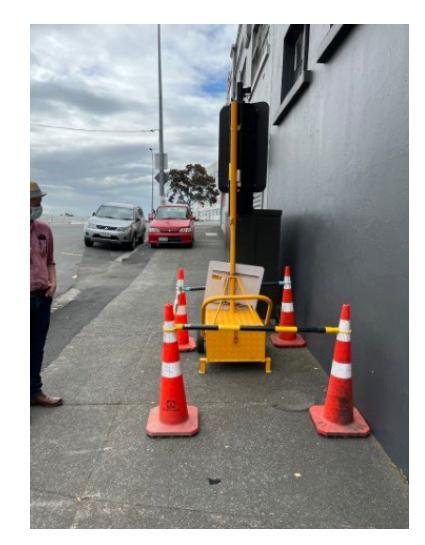
Photo 20: Unused mobile traffic lights left on footpath

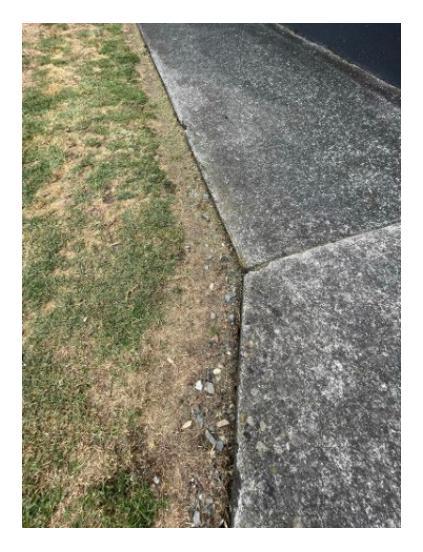
Photo 21: Drop off along the footpath edge creating a fall hazard for ambulant people and an overturn hazard for mobility equipment users

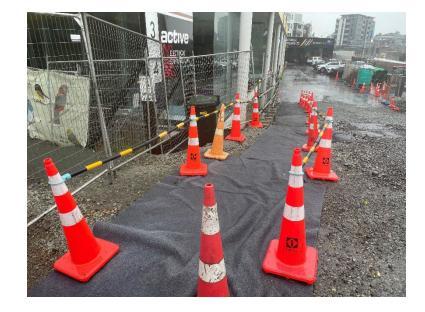
Photo 22: Carpet over gravel is folded and not secure. No clearly delineated line of travel for Blind and sight impaired pedestrians

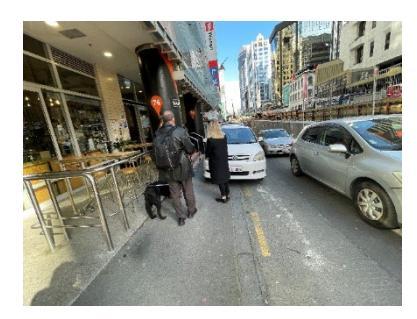
Photo 23: Car parked on footpath whilst unloading items for business. No loading spaces provided for local businesses during construction

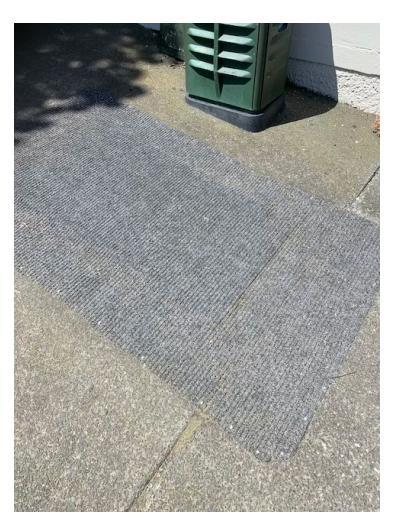
Photo 24: Bolted down carpet over raised utilities cover

- d. Ensure that utilities service covers are flush with the surrounding surface and are slip resistant, even when wet. Where raised utilities coverings are unable to be rectified immediately, consider the use of bolted down carpet to eliminate the trip hazard (Photo 24), or highlight with high visibility slip resistant paint.

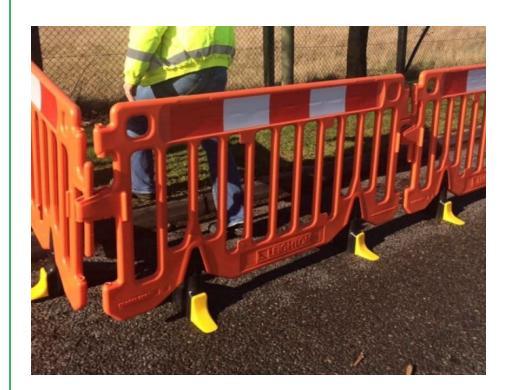
Photo 26: Clearpath Safety Barrier with anti-trip feet

8. Recommend solid temporary safety barriers, e.g. Clearpath Safety Barrier with anti-trip feet (Photo 26); safety barrier on Quay Street (Photo 27).

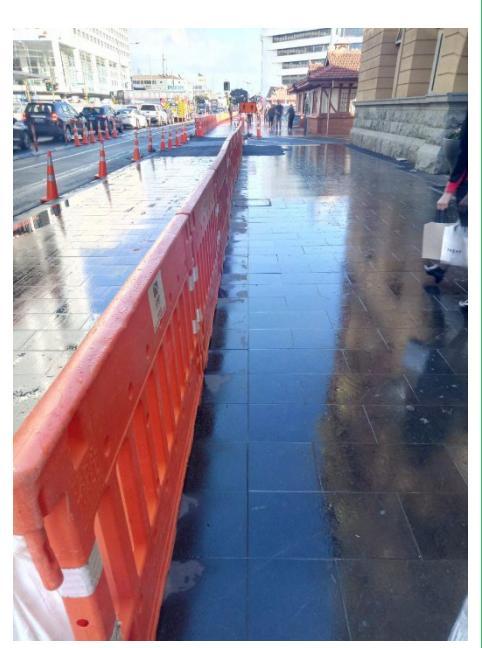
Photo 27: Solid safety barrier on Quay Street

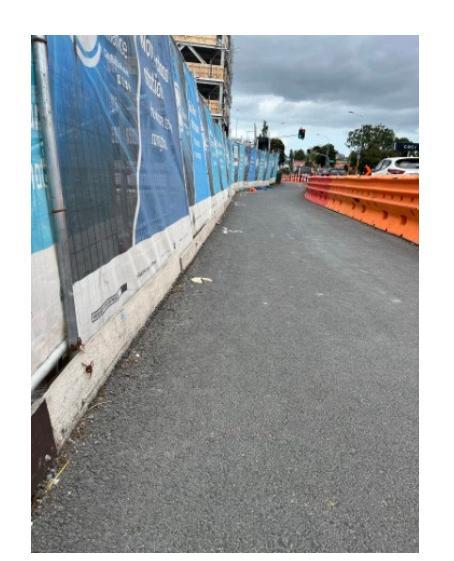
Photo 29: Good example of Heras fencing with no protruding footings and continuous kickboards.

6. Where construction site fencing does not go to ground level on the footpath side of the fence, install continuous cane detectable kickboards along the base of the fence, that colour contrast to the ground surface, to provide a detectable guideline for people who are blind or have low vision and who are using a cane (Photos 29 and 30).

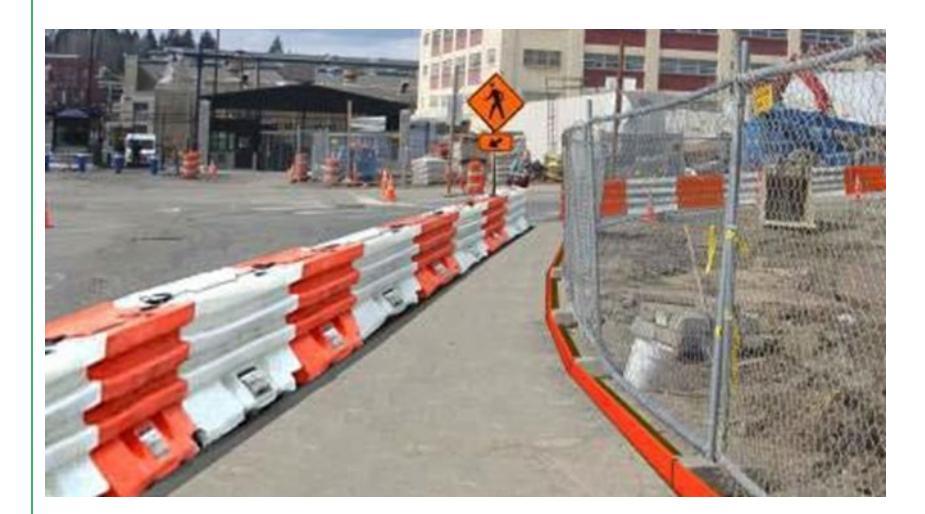
Photo 30: Excellent example of:

- a. Detectable, colour contrast edging firmly attached to Heras fencing footings.
- b. High visibility, interconnected vehicle protection barrier.
- c. Directional sign clearly visible and not affecting clear footpath width.

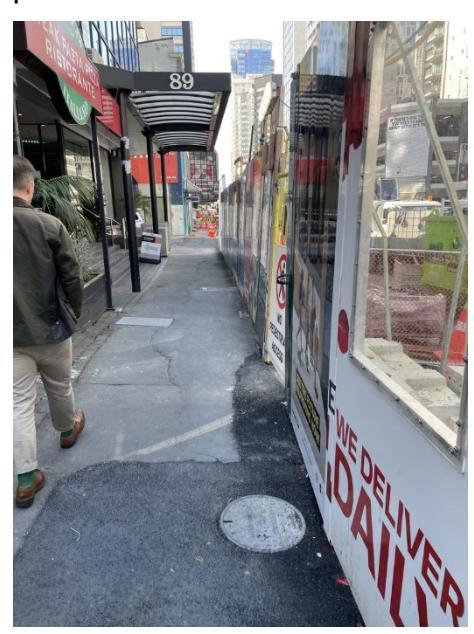
Photos 31 and 32: Windows in hoardings adjoining narrow walkways. Hoardings go to ground level, providing a clear guideline for blind and sight impaired people

7. Consider including windows in hoardings around construction site to allow more natural light through, particularly where the adjacent footpath runs through a narrow street or walkway, and to allow the public to observe the construction.

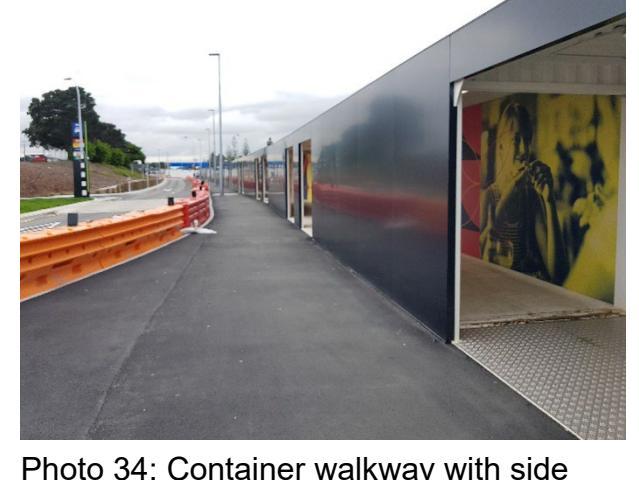
Photo 34: Container walkway with side openings and optional external path

4. For long enclosed walkways, consider side windows to allow natural lighting and if possible and practical, escape exit(s) to avoid entrapment particularly when being used in secluded areas or at night.
